## Evaluation of Long Term Effects of Erosion Due to Groin Placement in the Northern Yucatan Peninsula

EVALUATION OF LONG TERM EFFECTS OF EROSION DUE TO GROIN PLACEMENT  
IN THE NORTHERN YUCATAN PENINSULA

MASTER OF SCIENCE IN APPLIED ENGINEERING

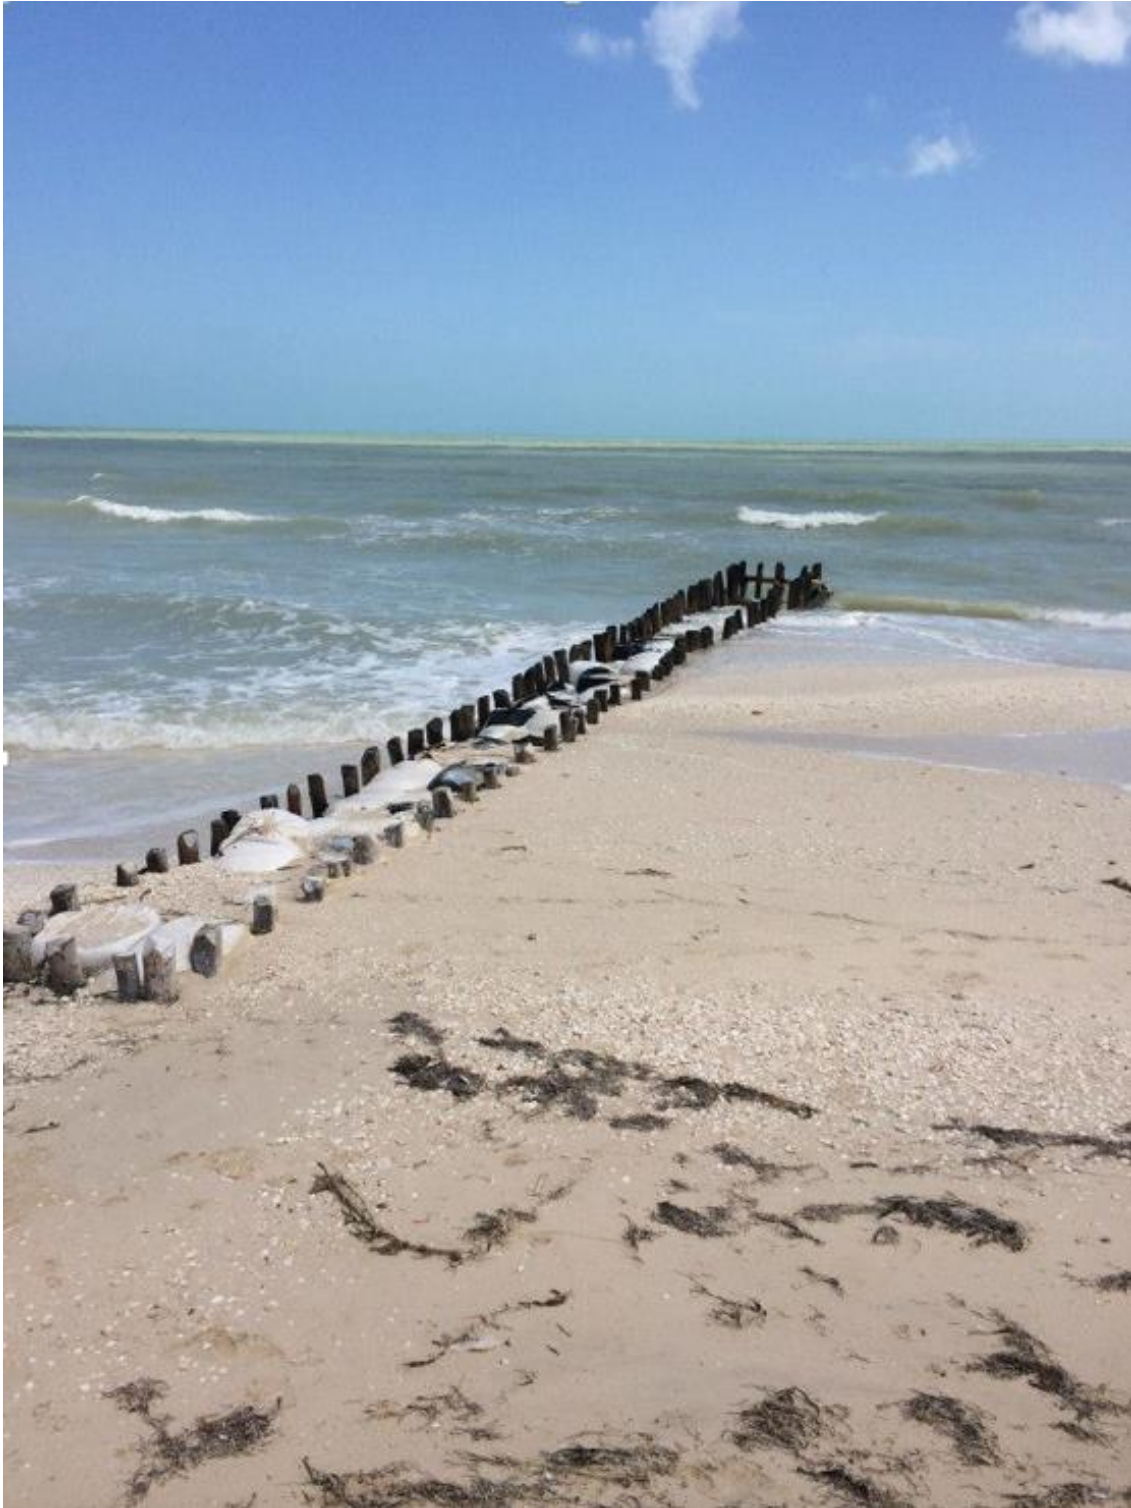
*Figure 1: Functioning Groin to the West of Progreso*

This research project took place in Chelem Beach Yucatan, Mexico. This strip of beach is experiencing major erosion problems because of the Progreso pier (Figure 1) and also residents illegally constructing their own groins for personal beach gain. The problem with this practice is that the blind use of groins can negatively impact the natural balance along the shoreline and accelerate sand erosion. This has caused great concern among local residents and the engineers that are tasked with fixing the problem. It is a slow and gradual process but Axis Ingenieria is taking appropriate measures to correct this problem. The six control points along the beach that are being monitored are providing the information that is needed to help restore the beaches of the northern Yucatan coast.

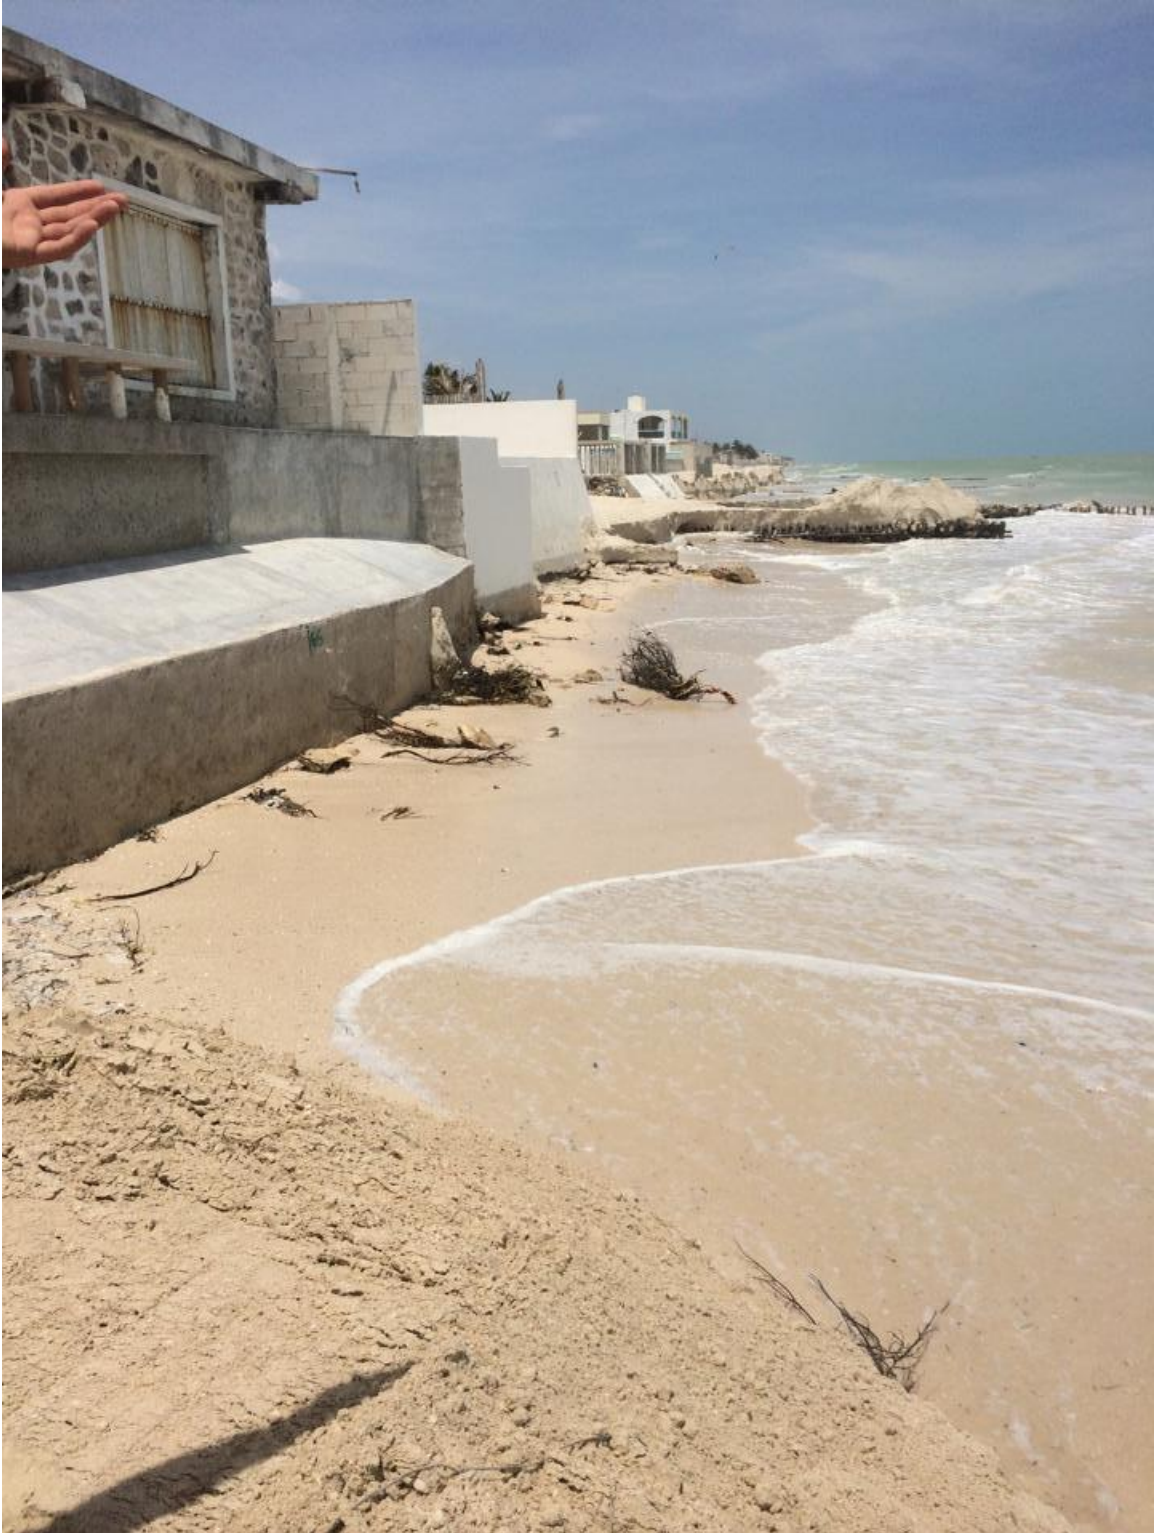
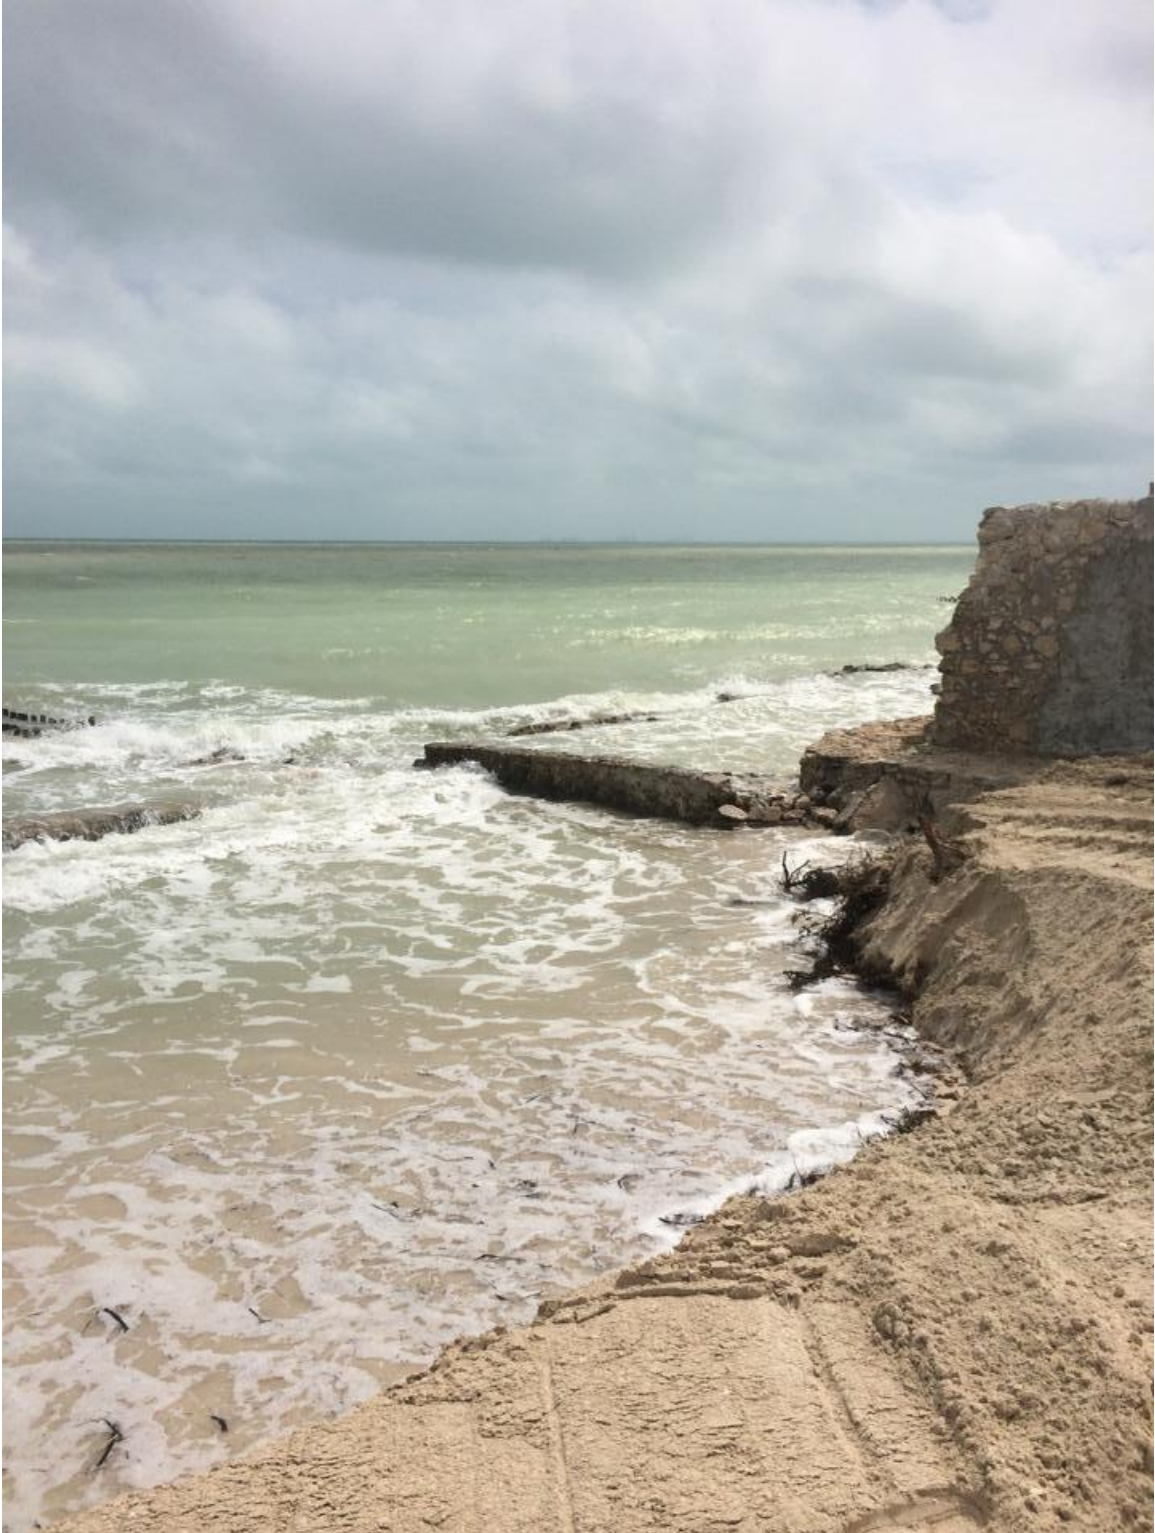
*Figure 2: Critical Zone West of Progreso Pier*

*Figure 3: Critical Zone West of Progreso Pier*

As a result of the coastline orientation along the Yucatan region, there are many critical erosion zones. The critical zones must be handled with care to ensure the loss of beach is kept to a minimum. The problem with erosion in this area exists because of the lack of understanding the process of beach dynamic changes. Often many factors that affect erosion are neglected thus resulting in the loss of beach. The Yucatan coastline experiences mild wave conditions ( $h_s=1\text{m}$ ) which is a result of the predominant northeast wind that affects the area (M. Alejandra Lira-Pantoja, 2012). The term  $h_s$  stands for significant wave height of the swell. Erosion is caused by wave conditions and also by improper usage of groins. In the case of the northern Yucatan shoreline, the main cause of erosion is the Progreso pier for the Chelem beach area, but improper usage of groins collectively affects the whole northern Yucatan coastline. Chelem beach is located approximately 5 km west of the Progreso pier. The Progreso pier is a 6.8 km long structure where the first 2.1 km is composed of arches that allow sediment to pass through. The pier was originally composed of the 2.1 km arched structure. Years later, an additional 4.7 km of impermeable structure was added to the pier bringing the total length to 6.8 km. The problem with the pier is that it acts as a 6.8 km groin that blocks the natural littoral drift from taking place. The movement of sediment is essential to maintain healthy beaches. The area to the right

of the pier is not experiencing erosion problems because the direction of sediment transport is from east to west. Chelem Beach which is the area to left of the pier is experiencing the shallow effect, which is the effect that blockage of littoral drift has on the surrounding area. This causes the area to the left of the pier to be deprived of sediment that is naturally being transported by the current. The current is still in place however in Chelem beach which aids in the transport of sediment westward from Chelem. This problem has been addressed in a couple of different ways. One of such methods is through the usage of groin structures which are the most commonly used approach to help combat erosion. Although groins are very useful structures, in this region they are often not properly utilized. The majority of the landowners in Chelem are foreigners who seasonally visit during the summer and winter months. When they saw their beach was eroding, they illegally constructed groins without the proper engineering (Figure 2) in hopes of replenishing the sand on their property. However, when groins are not carefully installed, they have the same shallow effect on the adjacent area just like the Progreso pier and the area to the west of it (Figure 3). This is the root of the erosion problem in this area. According to Kraus, the correct way to get the erosion problem under control is to remove the old groins and properly install a collective set of adequately designed groins in the area (Nicholas C. Kraus, 1994).

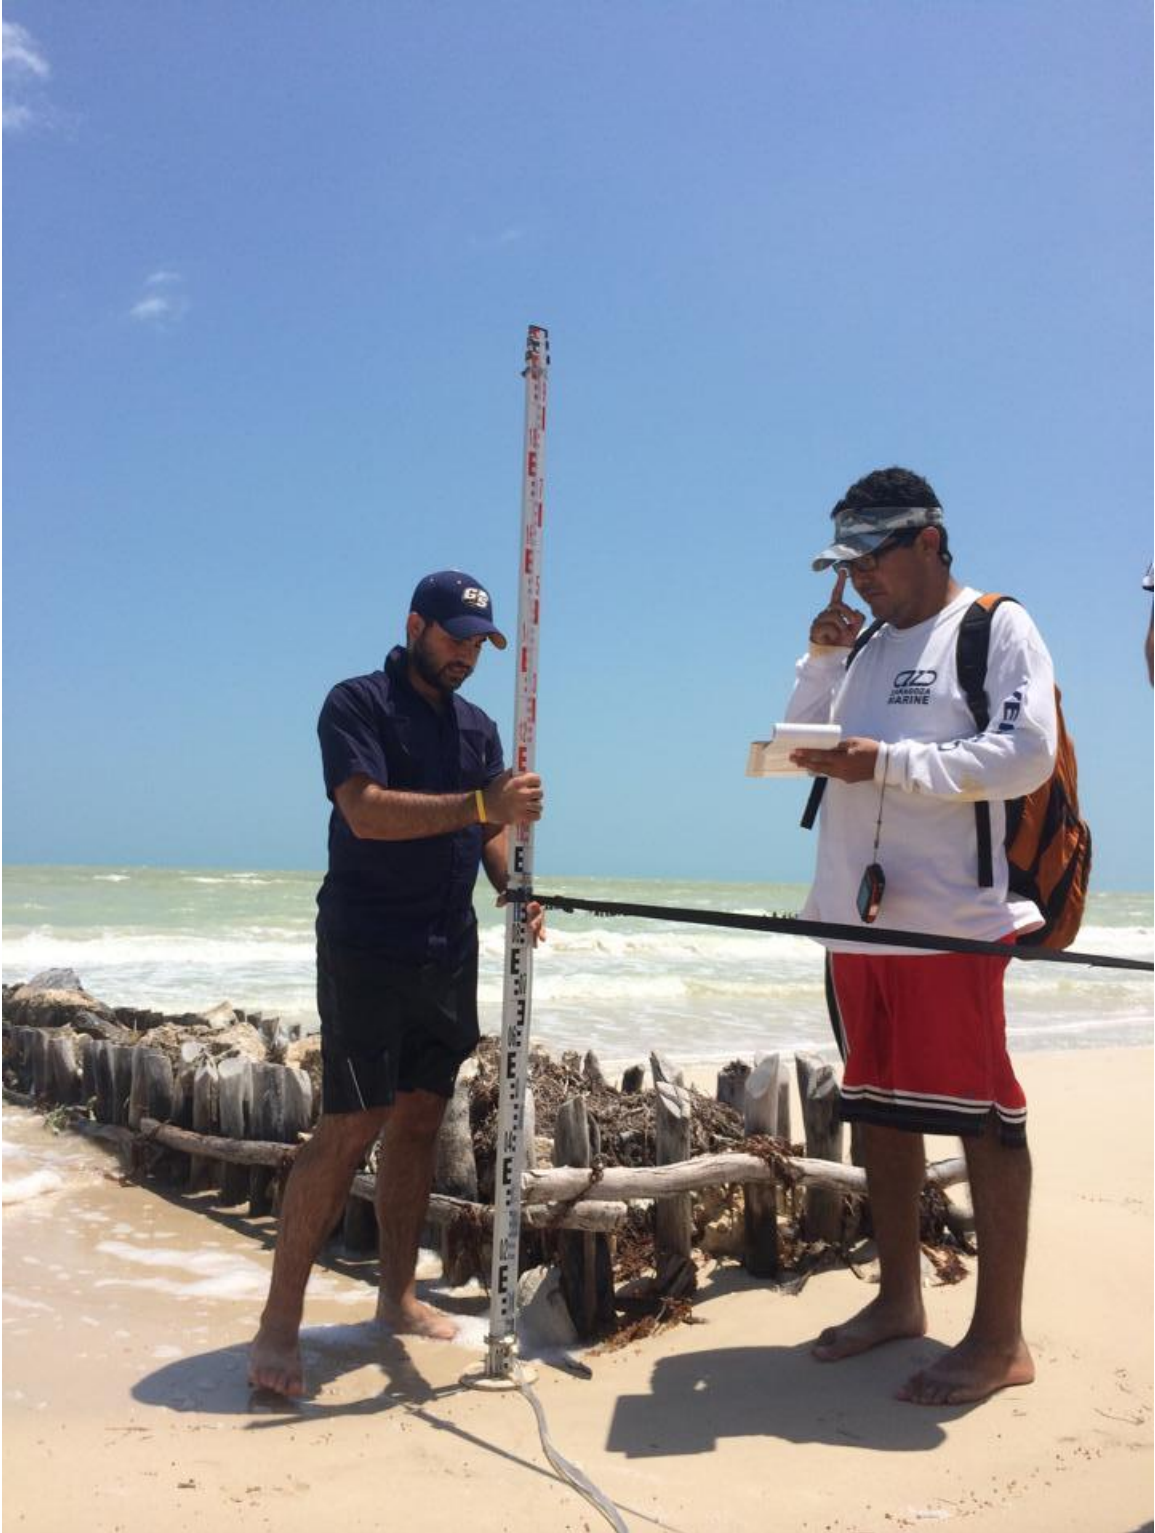
*Figure 4: The Emery-Method*

incorporated in the apparatus (Francisco Andrade, 2006). There are two transparent acrylic tubes that are 1.2-1.5 meters long and have the same diameter of 1-1.2 centimeters as the plastic hose (Francisco Andrade, 2006). There is also 5 meters of nylon string as well as two 90° plastic elbows that fit the plastic hose and acrylic tubes (Francisco Andrade, 2006). The plastic hose is inserted into the elbows and the acrylic tubes are inserted in the other side (Francisco Andrade, 2006). The tubes are parallel with the rods and filled with water to a height of approximately half of the rods. The theory behind how this works is based on the physical principle of communicating vessels which states that a fluid in communicating vessels forms a surface in hydrostatic equilibrium (Francisco Andrade, 2006). If both ends of a hose filled with water are equally graduated and placed vertically side by side, then different readings of water level in them will indicate differential elevation (Francisco Andrade, 2006). With these modern adaptations of the method it has become even more efficient and popular (Figure 4). More information concerning the usage of the Emery-Method in the methodology of the project is included in chapter 3.

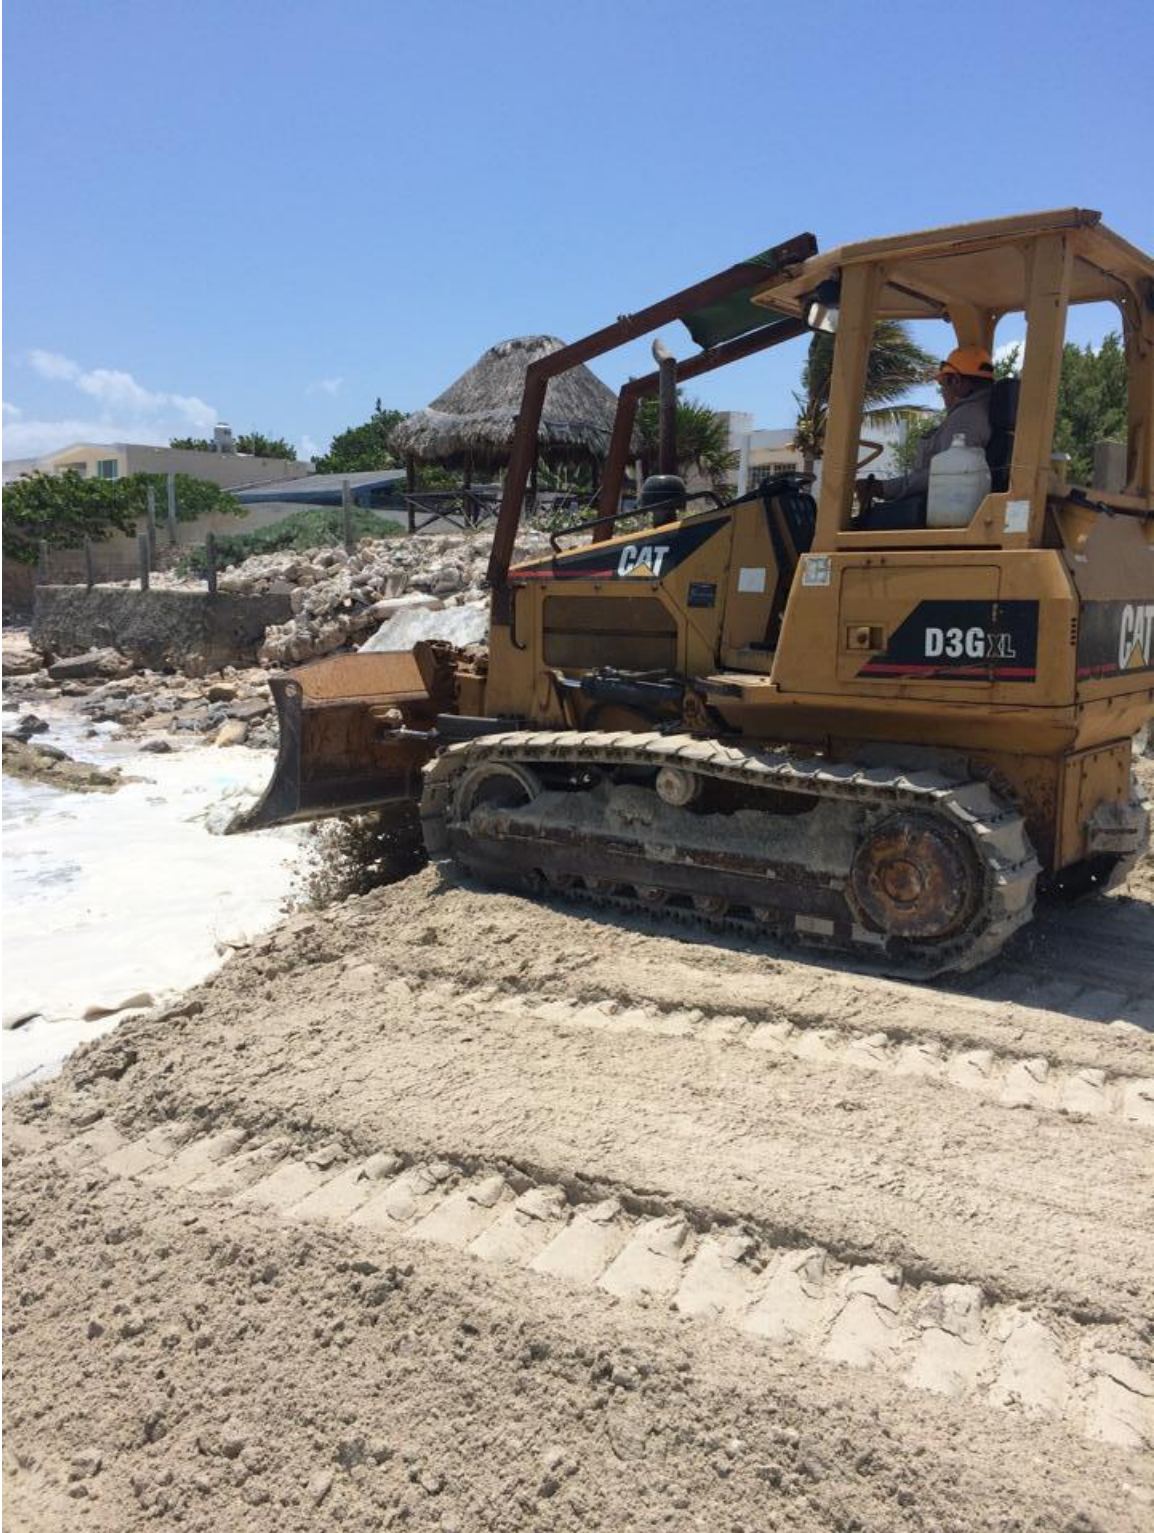
*Figure 5: Sand Brought in for Beach Re-Nourishment*

The topic of erosion on the Yucatan coast has been an ongoing issue for the last several decades. Unfortunately, there has not been a great deal of research done on the topic of erosion caused by coastal structures which is the root of the problem in Chelem. However, there is one particular study that was done that is very informative on the topic. The study was done on the 6.8 km Progreso pier to evaluate the near-shore wave transformations and sediment transport patterns (M. Alejandra Lira-Pantoja, 2012). This study was set up using an acoustic Doppler current profiler (ADCP) that was installed at a depth of 8 meters in the ocean. The study concluded that there are high erosion rates caused by the blockage of sediment transport to the west of the Progreso pier. The erosion rate for Chelem beach was calculated to be about 1m/year (M. Alejandra Lira-Pantoja, 2012). As a result of this high erosion rate, there has been devastating coastal infrastructure damage along a stretch of 10 km of beach west of the pier including Chelem Beach. It is noted that because of wave diffraction, the sediment transport regime closest to the pier on the west side travels east. After the reversed sediment transport adjacent to the pier, it returns to a westward transport regime. The study has also shown that as a result of the pier being constructed, the mean wave height of waves west of the pier has decreased which in turn diminishes the summer profile beach recovery that would normally take place. The final conclusion of the study is that beach erosion in the Chelem area is enhanced by the presence of the 6.8 km pier and it directly decreases the beach recovery capability of the Chelem area (M. Alejandra Lira-Pantoja, 2012) (Figure 5).

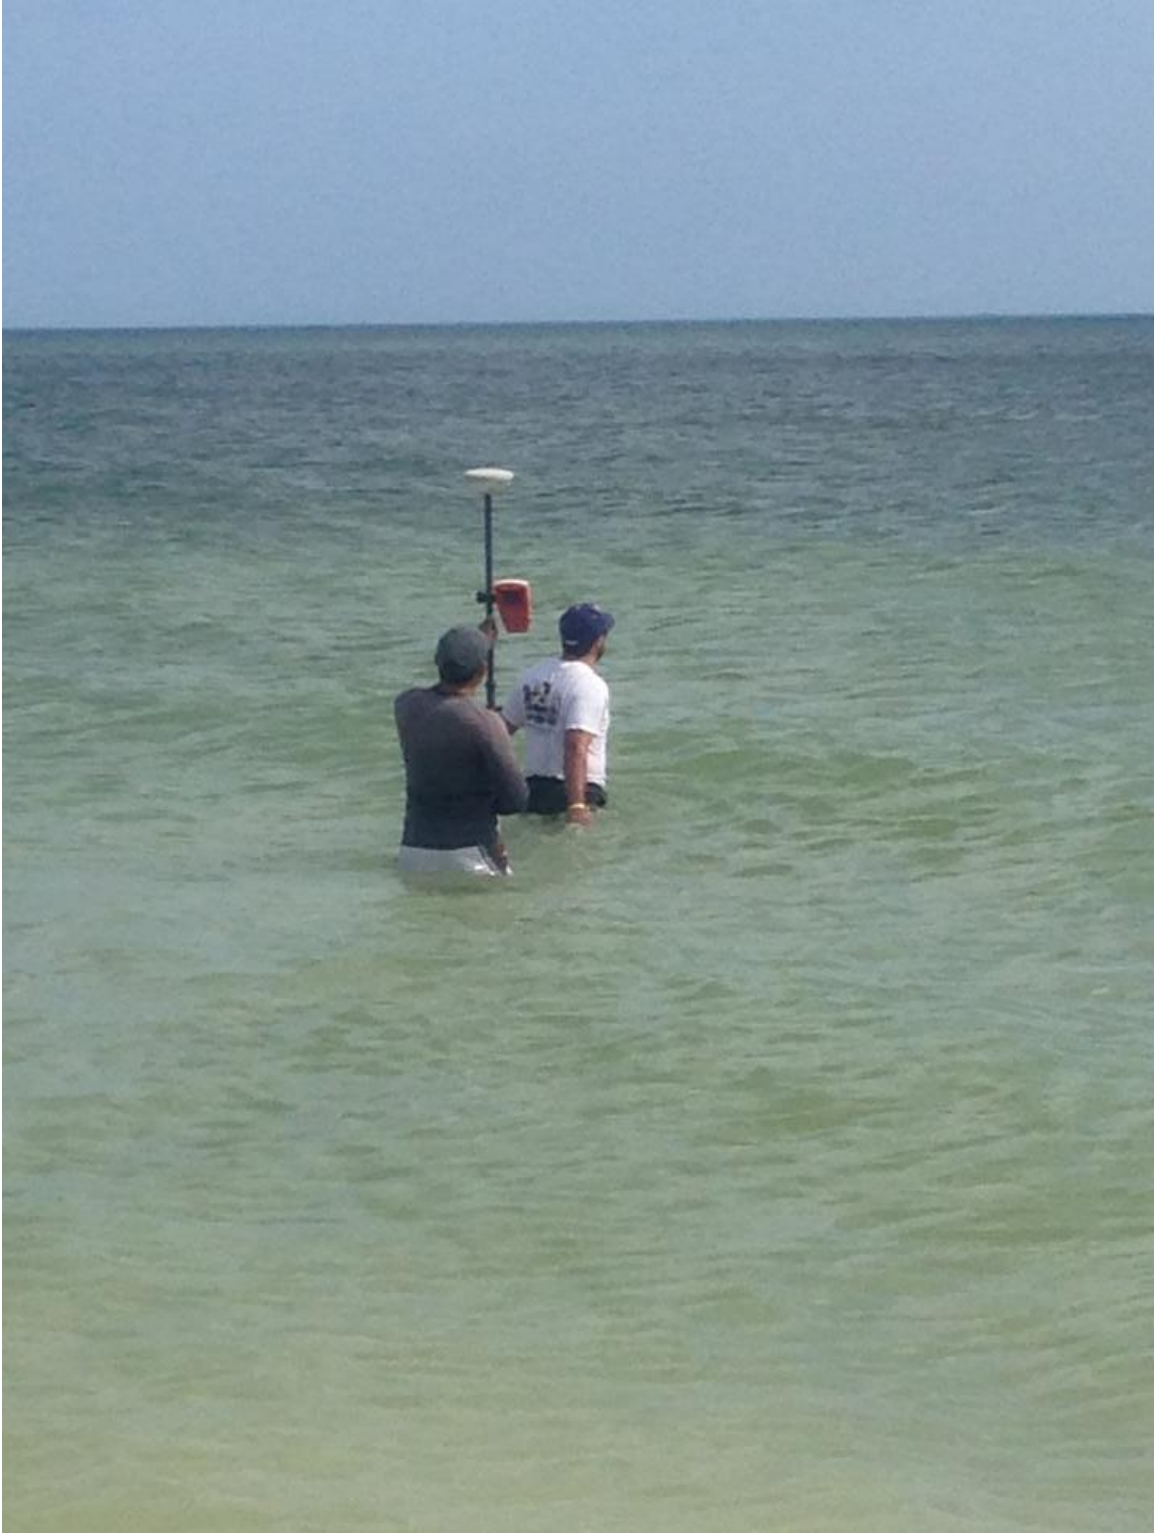
*Figure 6: GPS Survey of Beach*

was used (Figure 6). The model was a Leica GS14 GS15 and GS09 receivers. They are capable of receiving GNSS RTK and radios of up to 35 watts of power. The GPS instrument was attached to a pulley with wheels so the beach profile could be obtained. The GPS was run from the beach into the water in one hundred meter intervals to obtain an extensive profile of not only the land but also the seafloor (Figure 6). The GPS started up on the beach where the sand was, and then it was walked all the way into the ocean about fifty meters out. It was set up to record the elevations in one second intervals. This allowed the GPS to obtain a very accurate beach profile. Since the profile was taken out into the water, it gave a better understanding of the true profile of the beach. A preliminary beach profile is needed to determine the critical zones. A critical zone is an area where the erosion is large enough to produce property damage and loss. The critical zones must be identified in order for the control points to be placed along the beach. They are placed at the critical zones for the sole purpose of monitoring those zones extensively through weekly beach profiling. The control points were placed on the beach by the Axis Ingenieria. They were monitored weekly by their surveying crew which I was a part of from May 2014- June 2014. GPS surveys of the 17 kilometer stretch of beach were conducted throughout the durations of the study.

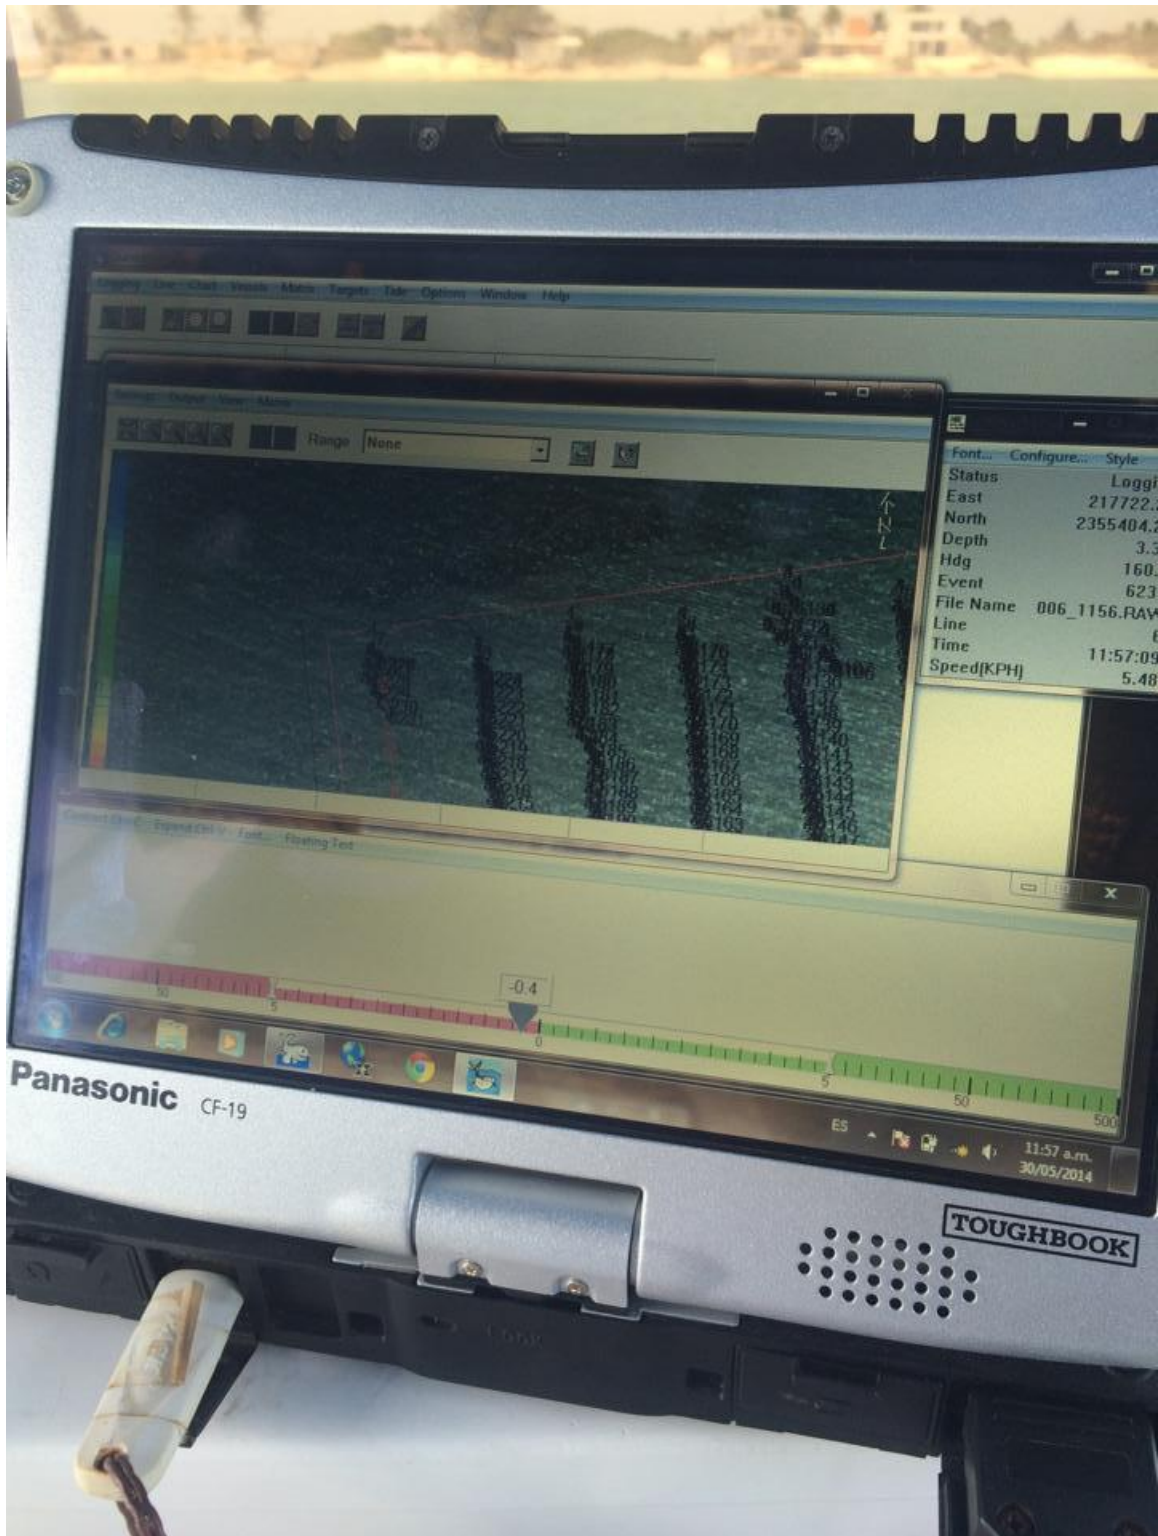
Figure 7: Collecting Bathymetric Data

The next step was to conduct a bathymetric survey in the water surrounding the six control points. A bathymetric survey is a survey that measures the water depths in a body of water. This information is used to profile of the ocean floor. The procedure for doing this type of survey is very straightforward. First, the lines to be followed by the boat conducting the bathymetric survey must be drawn in a CAD program. These lines are generated accurately using GPS coordinates. The lines extend out 3-5 km from the beach out to the ocean. This is done to obtain accurate results. The device that is used to conduct this survey is called an echo-sounder. The one used for this survey was a SYQWEST model 50MF. A Valeport Midas Surveyor with GPS integration was also employed to conduct the bathymetric survey. The echo-sounder is attached to the boat and submerged in the water throughout the data collection process. The echo-sounder transmits a pulse wave that is reflected off of the ocean floor and back to the device (Figure 7). This is how the depth is measured and relayed back to the computer. This is recorded in 1 second intervals for optimum results. The boat must then be positioned as close to the sand as possible to start the survey. The boat travels at a relatively slow speed of 4-5 knots in order to record the data. Once the line is completed, the boat goes on to the next one until all the data is recorded. This is important because the bathymetric survey when coupled with the beach profile gives a detailed description of the pattern of sediment transport. It shows exactly where the sediment taken off the beach is deposited on the ocean floor. This is key to properly identifying where to place the groins. Bathymetric surveys were conducted regularly throughout the course of this study.

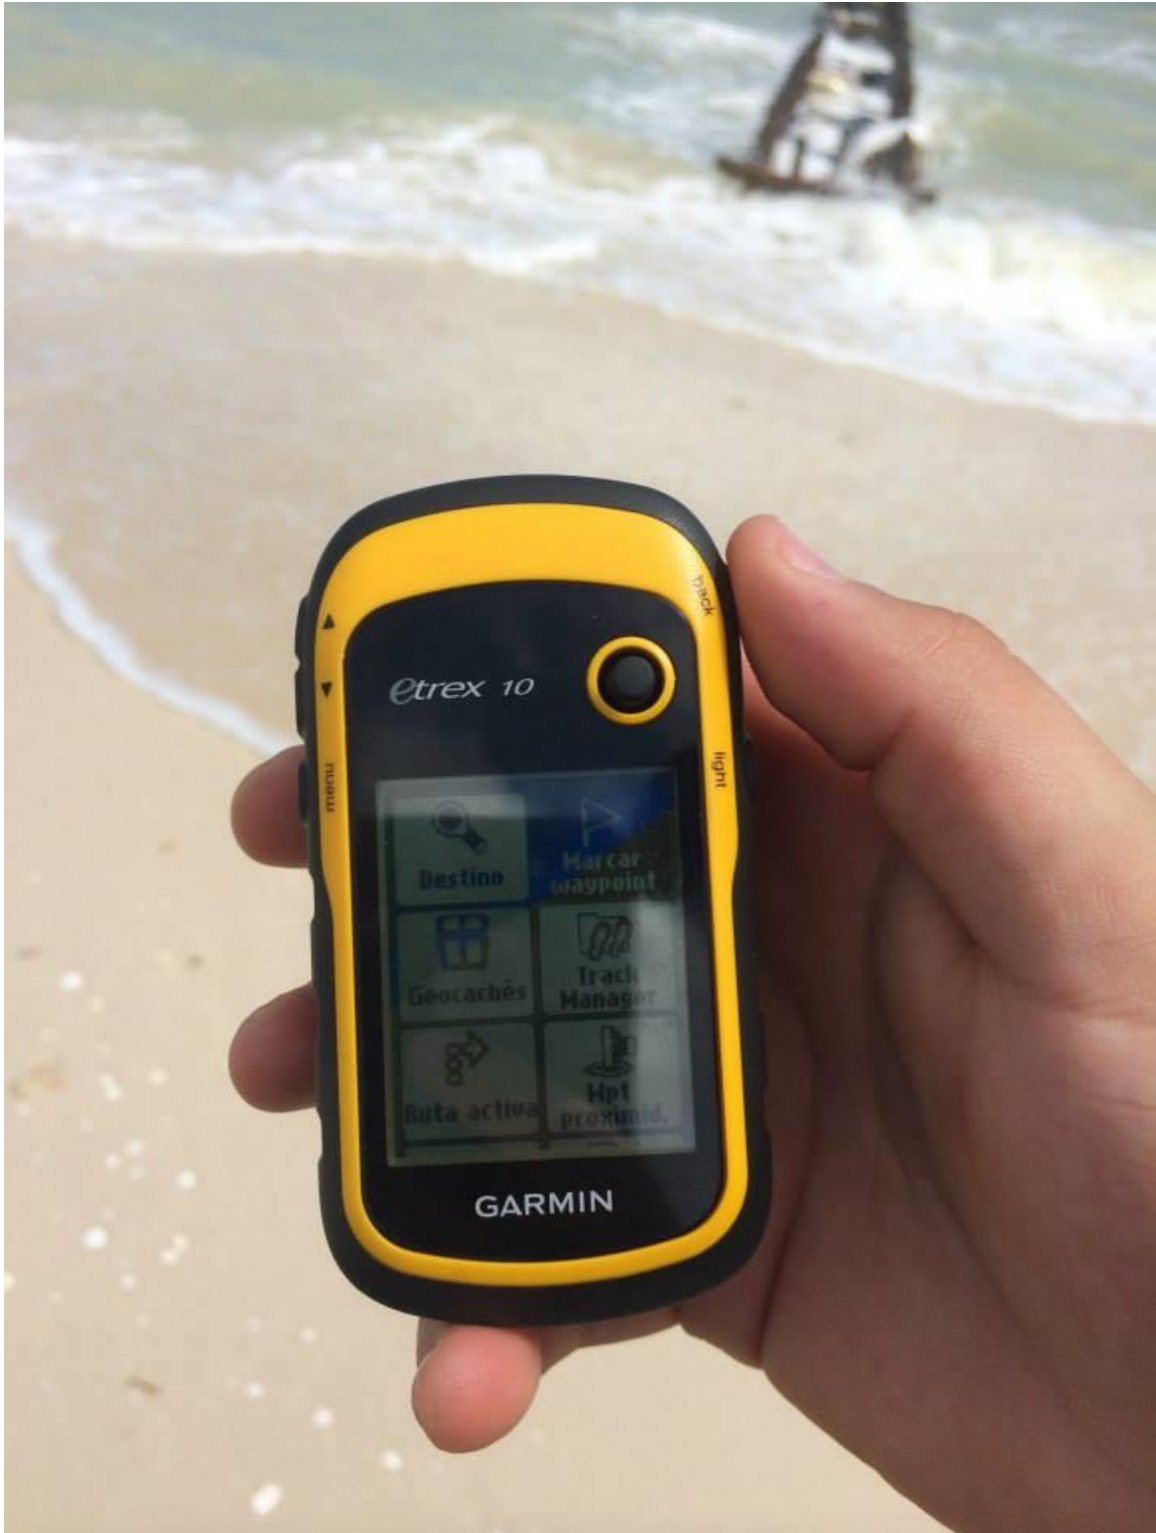
*Figure 8: Creating GPS Locations of Groins West of Progreso Pier*

in the area where the critical erosion zones were the worst. The purpose of this was to monitor the progression of the most eroded beaches in the region, and see the positive results at the end of the study.

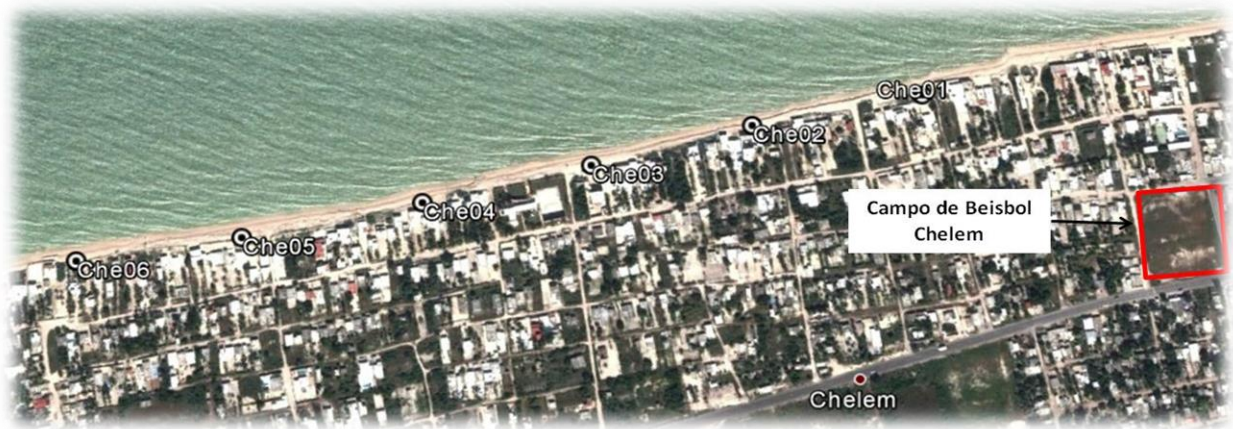
*Figure 9: Overhead View of the 6 Control Points*

The project on restoring Chelem Beach located 5 kilometers west of the Progreso pier has been an ongoing process for the last couple of years. Numerous projects have been undertaken with not much success. The groins engineered and installed by Axis Ingenieria have been in place for a little under a half of a year and are being monitored weekly using the Emery-Method to gather data. As the data was collected weekly, it was also analyzed to make sure the groins were performing as they were supposed to. The results of these findings and observations are presented in the following sections. The six control points have been set up roughly 200 meters apart from each other, encompassing approximately 1200m of Chelem Beach (Figure 9). Figures 10-15 show the morphological change of the profiles over the 6 month monitoring process where 0 on the graphs is the location of the control points.

Control Point 1 is located approximately 5 kilometers west from the 6.8 km Progreso pier (Figure 9). The sediment transport erosion problem starts just west of the pier which is why the control points were set up starting in this location and going westward. At this location there is an existing concrete slab that extends out into the ocean which is acting like an impermeable groin. This structure is attached to a house (Figure 3). Although the house is not supposed to be exposed to the water, the erosion is so large that the house is no longer safe to live in and the erosion downdrift from it at control point 1 is very strong. This is the primary reason why the government decided to use groin structures in this area of the shoreline. The original profile of the beach at control point 1 extended out to approximately 28 meters from the top of the profile measured out to the water when initially measured on April 1<sup>st</sup>, 2014. As mentioned earlier, the tides were taken into account when measuring the profiles in order to keep the data consistent. After analyzing the groin on a weekly basis, data from this control point shows that the beach profile has regressed (Figure 10). The last Emery-Method profile that was taken on September 10<sup>th</sup>, 2014 shows that the profile extended only to approximately 24 meters. One possible reason for this is the concrete slab that is exposed to the ocean that is adjacent to the control point. This slab is causing major erosion problems with sediment transport downdrift to the control point because of its close proximity. The best way to correct this is to completely remove the slab. However, this is not currently possible because the slab is part of the house and the local authorities do not have permission to remove the structure. After running the CEDAS program, it was determined that there was a reduction in the total volume of sand in the profile by 12.401 cubic meters. The horizontal length of the profile measured from the start of the sand on the beach out to the water also receded by 6.76 meters. Axis Ingenieria has proposed to combat this

Control point 2 is located just west of control point 1 by roughly 200 meters (Figure 9). This is the second control point in the series of 6 points that are being monitored for erosion. The initial profile taken on April 1<sup>st</sup>, 2014 indicated there was 22 meters of sand from the control point to the water. The most recent recording from September 10<sup>th</sup>, 2014 has shown the profile of the beach has replenished itself and extended out to approximately 27 meters long (Figure 11).

Control point 3 is located to the west of control point 2 by 200 meters (Figure 9). Control point 2 is more of a critical zone according to the data than control point 3. The initial profile was taken on April 1<sup>st</sup>, 2014 and it extended to 21 meters. This was actually worse than that of control point 2 however the results now are far better. The final beach profile taken on September 10<sup>th</sup>, 2014 measured the profile to be at 35 meters (Figure 12). This is very significant because it validates the basis of the research of how the groin structures positively affect the restoration of the beach. Control point 3 has gained 14 meters of beach in the six months that the groins have been installed and monitored. The reason for this is that control point 3 is downdrift enough from control point 1 and the slab of concrete in the water that it doesn't affect control

Control point 4 is 200 meters downstream to the west of control point 5 (Figure 9). The initial profile of the beach taken on April 1<sup>st</sup>, 2014 gave an initial length reading of about 21 meters of beach. As shown in figure 13, the profile was initially undernourished to a severe state.

Control point 5 is located to the west of control point 4 by 200 meters (Figure 9). The initial profile measure that was conducted on April 1<sup>st</sup>, 2014 had a distance of around 20-21 meters. This value lines up accurately with the initial profile readings from all the other control points. The final profile reading that was conducted on September 10<sup>th</sup>, 2014 had a reading of 30 meters (Figure 14). This is also very similar to control point 4 just 200 meters to the east. The initial and final readings are very similar however there is a noticeable difference in the elevations of the two profiles. While the elevation of the profile for control point 4 gained approximately 1 meter throughout the 6 months this project has been carried out, the elevation of the profile from control point 5 has gained just a couple of inches over the same six-month period. The possible reasons for this could be the permeability of the groin set up by the control

Control point 6 is located 200 meters to the west of control point 5 (Figure 9). This is the final control point that was set up and utilized for this experiment. This point lies approximately 5 km west of the Progreso pier. Control point 6 was arguably located in the second most critical zone (control point 1 is located in the most critical zone). The initial beach profile measurement
